Quality evaluation of crude oil pipeline welding joints by using NDT techniques, with a specific emphasis on X-ray radiography

The objective of this study is to evaluate the quality of crude oil pipeline welding joints used in Zueitina oil company was performed by two methods of NDT techniques, with a specific emphasis on X-ray radiography and PAUT ultrasound. Examining the effectiveness of NDT in detecting defects and These two tools enabled to identify the causes of welding defects as well as to determine the frequency of their occurrence and to identify the most serious welding faults and defects. Both methods – technical should reveal shortcomings in technological aspect. Their use should contribute to improving the welding process of pipes in operation and to increasing the safety of piping systems.

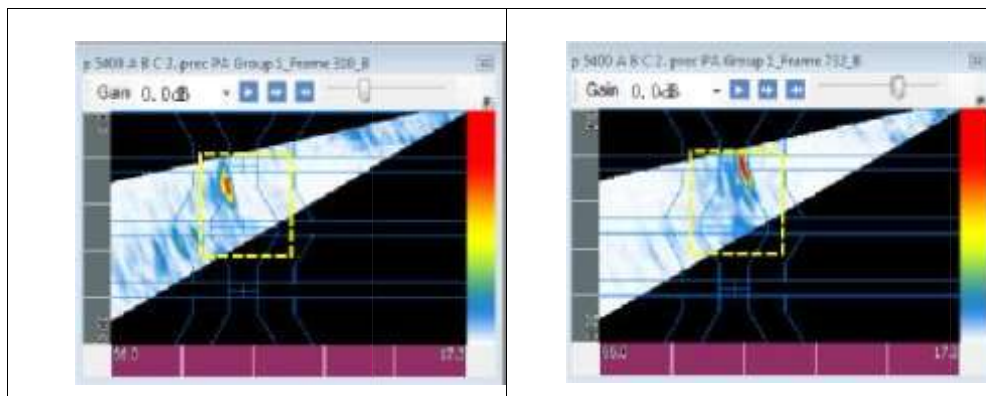
Figure (3) : The result of testing the first weld joint by radiography and PAUT ultrasound and the signs of the two visible interruptions in each of the two mentioned test techniques.

Figure (3) shows a cross-section and a side view of the second weld joint and the locations of the three discontinuities on it, which are a fracture in the upper region of the weld (toe crack), slag inclusions, and a second fracture in the upper region of the weld, according to their position in order, starting from zero.

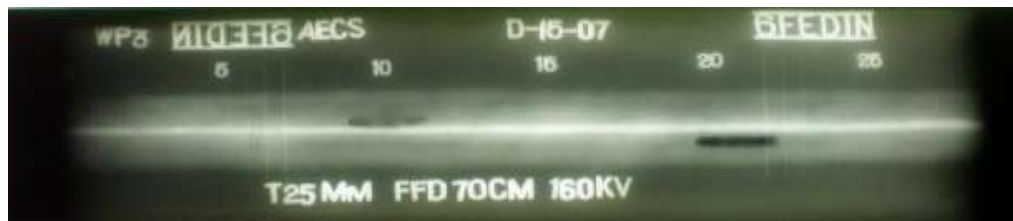
Figure (5): Test result of the third welded joint using radiography and guided beam ultrasound PAUT and visual interruption signals in both test techniques mentioned.

Figure (5) shows the radiograph and ultrasound images in the B, C & D scanning systems resulting from testing the third weld joint by radiography and directed beam ultrasound, respectively. As the figure shows, the radiograph revealed two signs of discontinuity resulting from the presence of slag inclusions in the weld joint, and recorded a weakly clear signal of the fracture in the root area. Likewise, no signal indicating the presence of the fracture in the upper layer of the weld was seen. While, on

the other hand, through the ultrasound images with directed beams, the signs of the four discontinuities, their nature, locations, and dimensions of each of them in the weld joint were clearly seen.

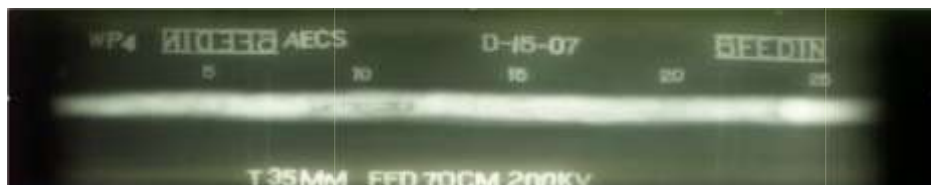
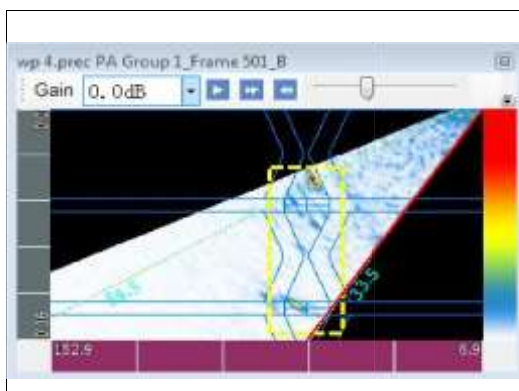
Figure (6) : The result of testing the fourth welded joint using radiography ultrasound, and visible interruption signals in mentioned test technique.

Figure (6) shows the radiograph and ultrasound images in the B, C & D scanning systems resulting from testing the fourth welded joint by radiography and guided beam ultrasound, respectively. As shown in the figure, the radiograph revealed the two discontinuity signals resulting from the presence of slag content in the weld joint. On the other hand, the test images using ultrasound with directed beams also revealed the two discontinuity signals, clearly showing their nature, position and dimensions in the weld joint.
